FACELIFT FOR AN OLD FRIEND: DISCUSSION ON OCEAN POOL REFURBISHMENT MEASURES AND CHALLENGES

J O'Reilly¹, B Mojsin¹, S Batt¹, M Zed², L Skountzos³, J Spencer⁴

¹WorleyParsons, Ports and Marine Terminals Group, North Sydney, NSW

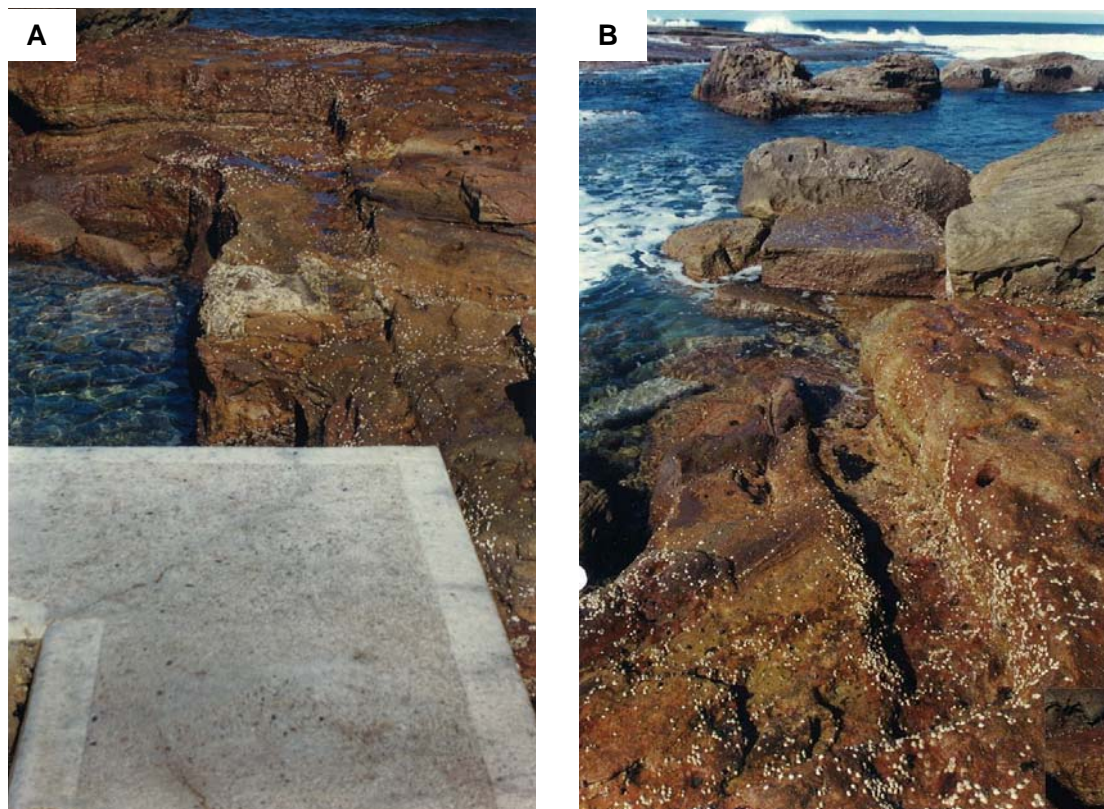
Figure 1: Evidence of trenches cut into the bedrock at North Curl Curl

At North Curl Curl ocean pool, it appears that the pool's pre-existing southern wall was founded on trenches cut into the natural rock (see Figure 1). This 400mm wide wall was destroyed after 10 years in service, during a storm in 1947, and was replaced by a wall 900mm in width, which was constructed in a revised location. (Mayne-Wilson, 1998).

These are thought to have housed the toe of the pre-existing narrow southern wall. (Source: Mayne-Wilson, 1998)

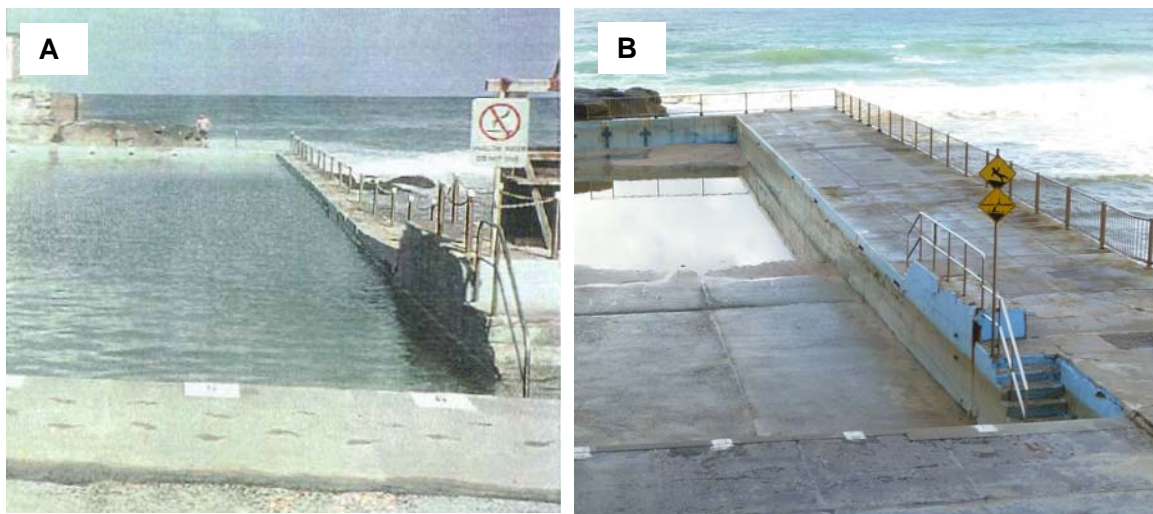
Figure 2: Queenscliff ocean pool

(A) Access along the southern wall apron is poor due to narrow wall width and encroachment of the chain rail. (B) The opportunity was taken to significantly widen the southern apron in 1999 when the Manly Lagoon outflow pipes were extended. (Source: DPWS, 1995; WorleyParsons, 7/2013)

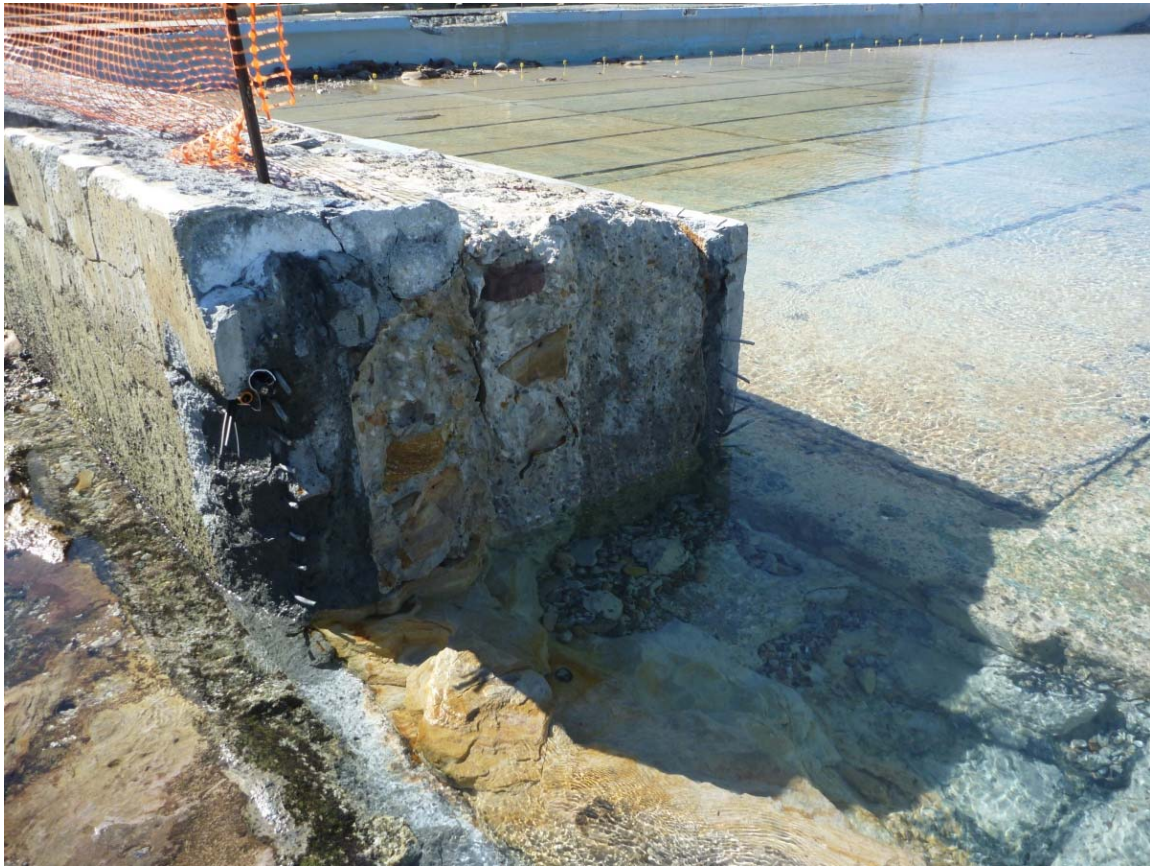
Figure 3: Demolition of the SW corner of Freshwater ocean pool

The south-western corner of Freshwater ocean pool was replaced in 2012 as part of a refurbishment and upgrade works package. The walls had sustained considerable damage at this corner, presumably from the stresses associated with changes in temperature and moisture. Upon demolition, it was discovered that the matrix of the wall contained sandstone boulders placed within the original parent concrete. It is likely that these boulders were locally excavated (or collected) and inserted within the concrete forms to economise on construction materials.

Exposing the materials used in the original construction of the pool wall and numerous subsequent widening and refurbishment works. (Source: WorleyParsons, 3/8/2012)

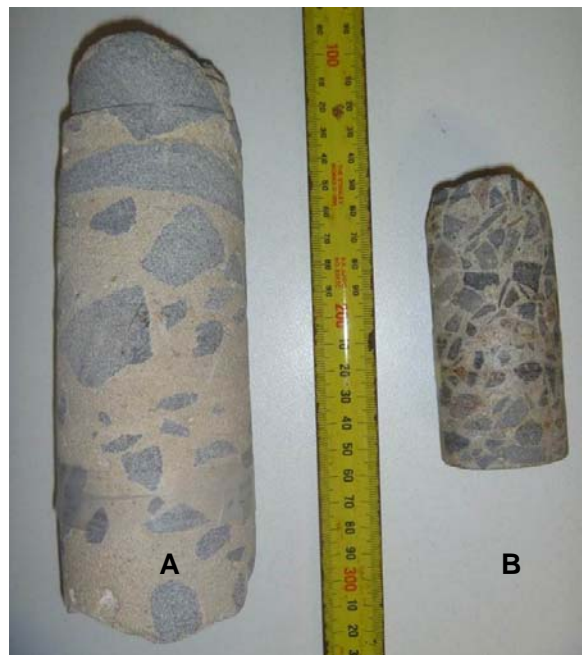
Figure 4: Concrete core samples

Core samples taken at South Curl Curl and Coogee show that the concrete used in the construction of these two pools had large coarse aggregate (see Figure 4). Roger Scerri (a Building Materials Research Engineer from SciMat Technologies) proposes that this indicates these concrete mixes were specifically designed for use in the marine environment. Use of large coarse aggregate was an early method of increasing the workability of concrete. It is therefore inferred that the mixes would have a high cement content with a low water:cement ratio. This theory is consistent with the findings made by Scerri (2002) following site testing and laboratory analysis of three core samples from Coogee, as follows:

- $f'_c = 24 \text{ MPa}$
- Cement = 400 kg/m³
- Water/cement ratio = 0.5
- Sulphate intrusion profile = 3 to 7 mm.

(A) From the northern wall of South Curl Curl ocean pool, showing coarse aggregate much larger than that seen today, with an apparent high proportion of fine aggregate, presumably due to the ready availability of beach sand during site batching. (B) Modern concrete with 10mm coarse aggregate. (Source: WorleyParsons, 10/2013)

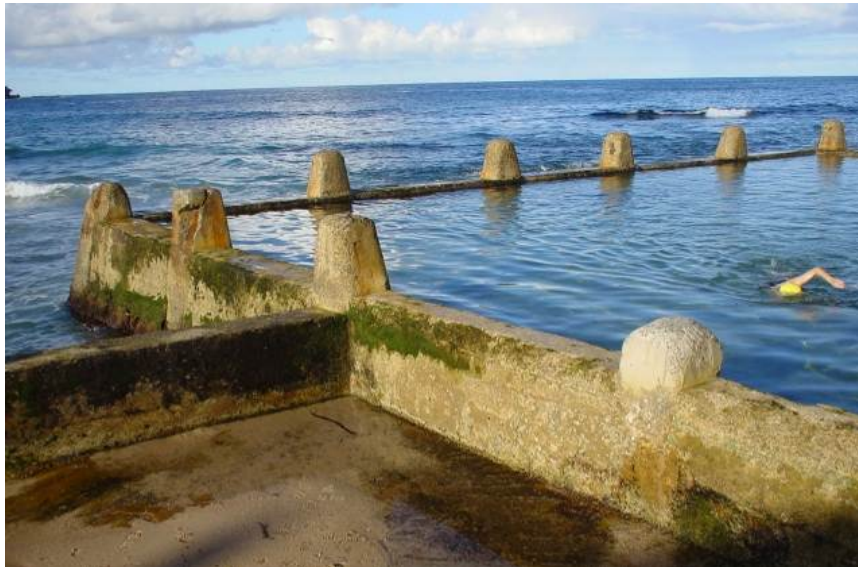
Figure 5: Ross Jones Memorial Pool prior to refurbishment in 2005

It was found that the deterioration mechanism of the concrete was both chemical and mechanical attack from sulphates naturally occurring in seawater, accelerated by the pounding, abrasive action of the surf (Coltman, 2002). (Source: WorleyParsons (inc. PBP), 2002)

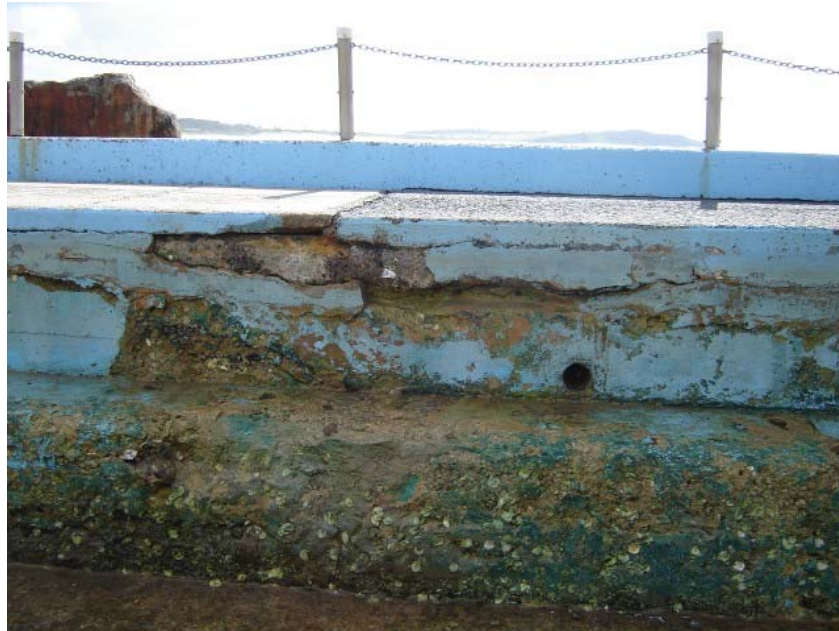
Figure 6: Copper sulphate algacidal solution has stained concrete and rock dark green inside Dee Why ocean pool

Copper sulphate has not been used by Warringah Council for over 20 years, but is thought to be responsible for accelerating the deterioration of concrete surfaces during its use (DPWS, 1995). At least two generations of apron topping replacements can be seen, alongside several generations of failed patch repairs. (Source: WorleyParsons, 9/2007)

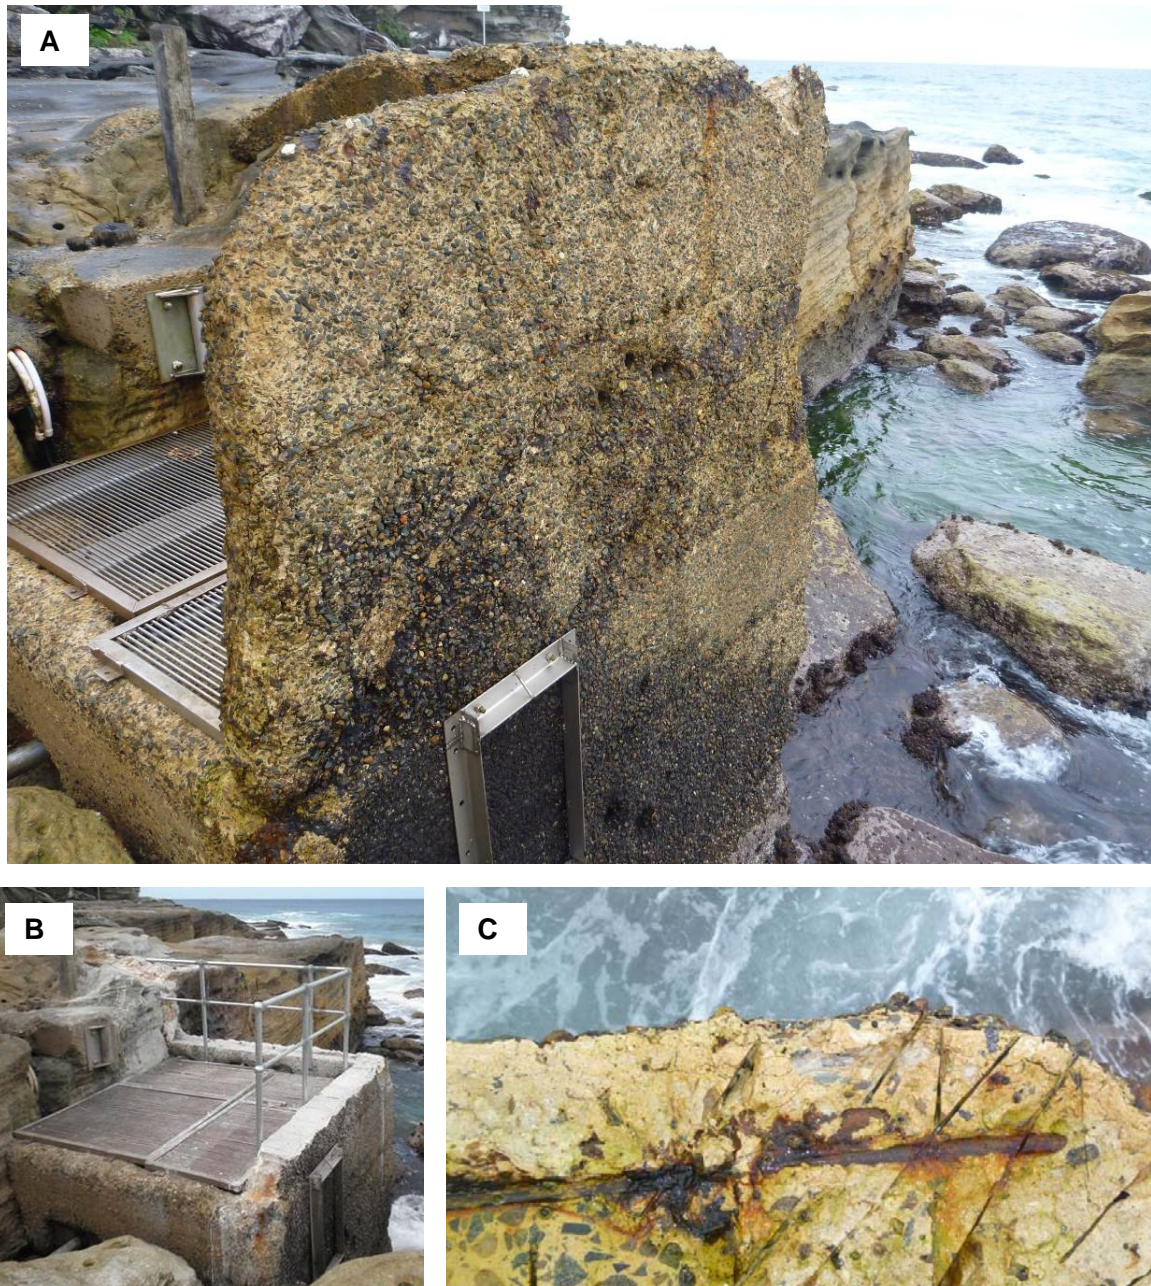
Figure 7: The pump wet at Queenscliff ocean pool

(A) The wave baffle walls in poor condition. The exposed coarse aggregate on the seaward faces of the concrete is a result of the combination of sulphate attack and abrasion from wind and waves. (Source: WorleyParsons, 9/2011) (B) The walls were demolished in April 2013 due to concern over their poor condition. (Source: Warringah Council, 4/2013) (C) A close-up of the concrete wall cross-section, post demolition. Corrosion of reinforcement was not a concern after an estimated 75 years in this severe environment. (Source: WorleyParsons, 7/2013)

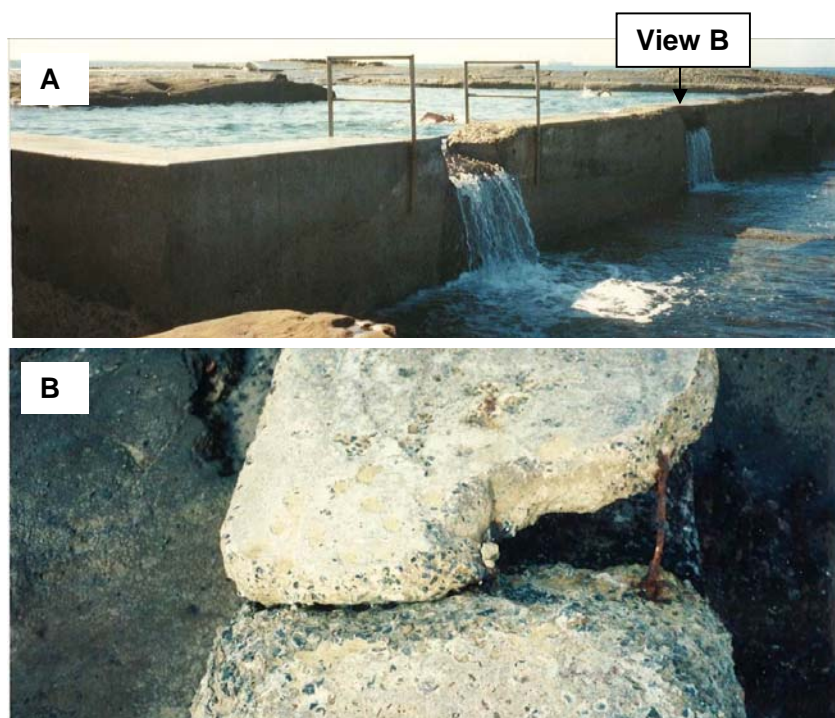
Figure 8: North Curl Curl Ocean Pool prior to repairs in 1998

The slender reinforced concrete scupper lids had sustained considerable damage: one was missing (A), and one other was in an unserviceable condition (B). A potential solution for slender scupper lids is being trialled by Warringah Council at Freshwater ocean pool (refer to Figure 19). (Source: WorleyParsons (inc. PBP), 1998)

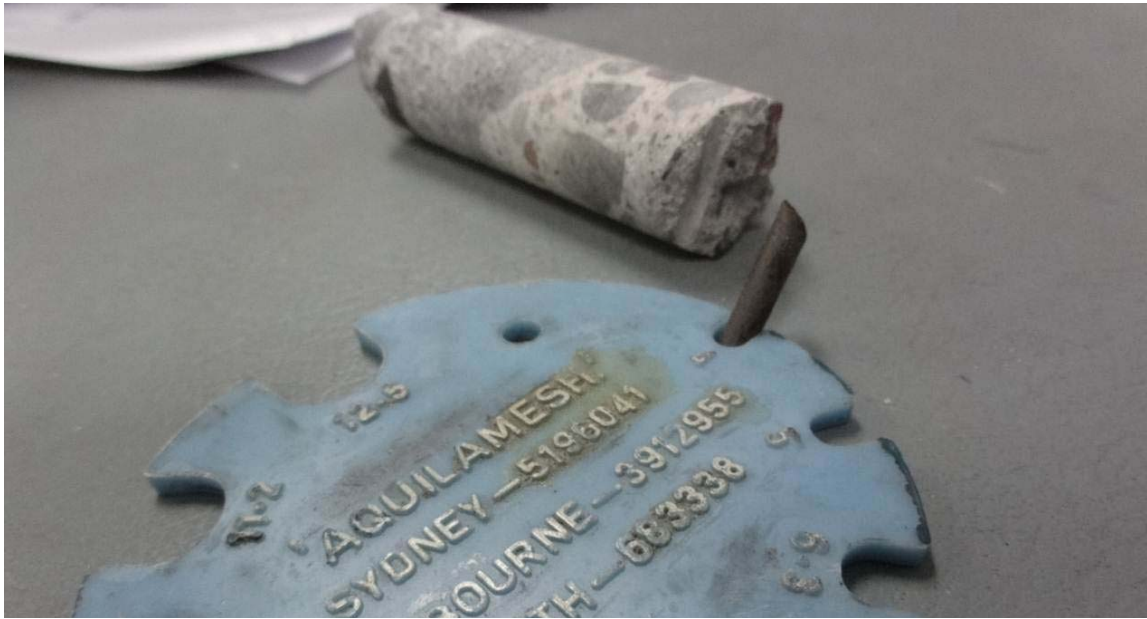
Figure 9: Core sample taken from the reinforced concrete pool floor slab at Yamba ocean pool

The core includes a segment of reinforcement and a sample of the bedrock foundation beneath. This section of floor slab was around 150mm thick. The reinforcement is measured to be around 4mm in diameter. The steel reinforcement shows no signs of corrosion after nearly 50 years in the marine environment. Patterson (2006) provides a hypothesis that concurs with this finding. (Source: Jim Spencer, 10/2012)

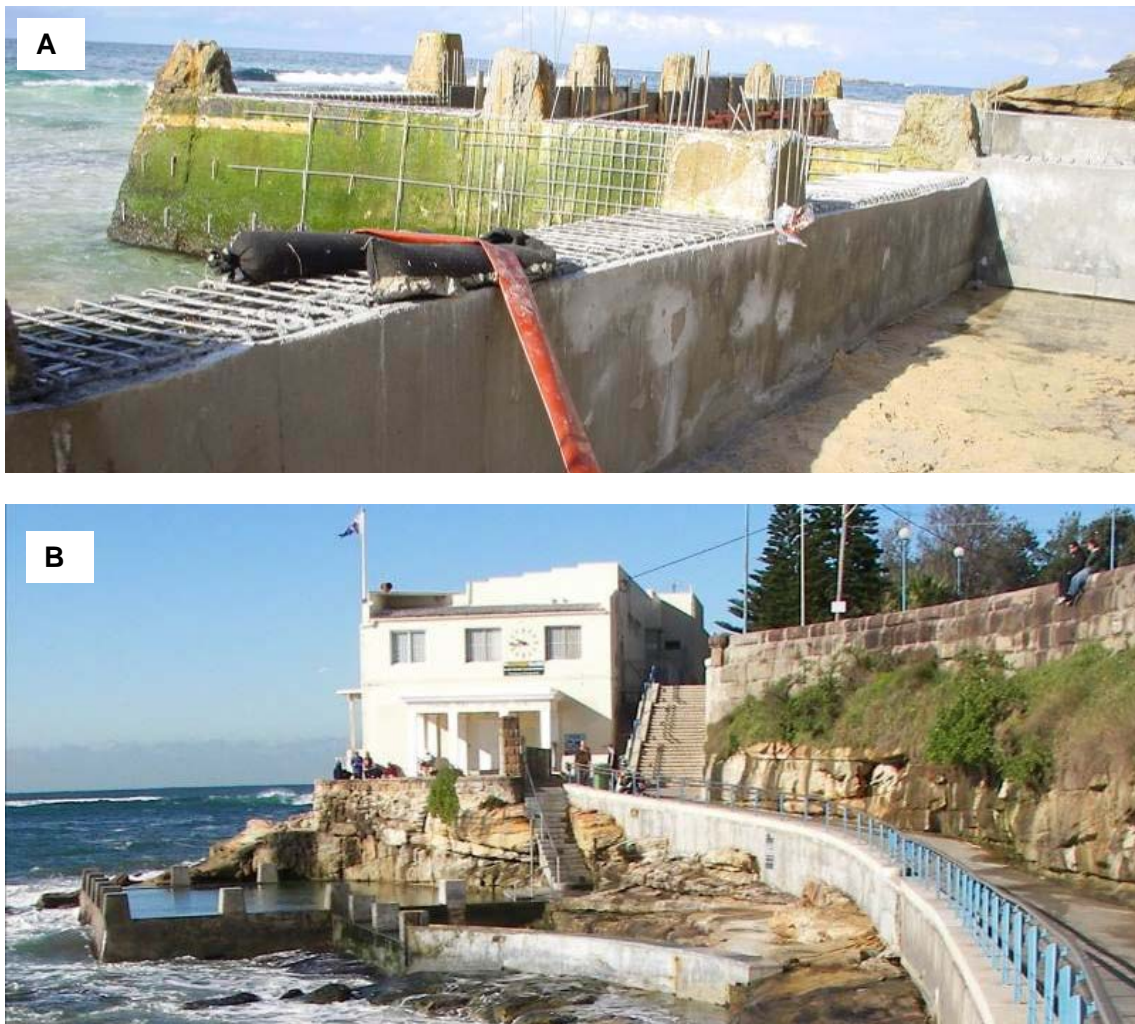
Figure 10: Ross Jones Memorial Pool

(A) Mid-refurbishment, during the winter of 2005. Note the dense, bright green marine growth on the concrete surface in the background, indicating that surface contaminants had been previously removed. (B) Some 2 years after refurbishment. (Source: WorleyParsons (inc. PBP), 7/2005 & 6/2007)

The Ross Jones Memorial Pool at South Coogee was refurbished by Metropolitan Constructions in 2005. The pool walls were resurfaced with a relatively thin reinforced concrete layer, placed in situ. Following an investigation and laboratory testing by Scerri (2002), it was found that despite its poor appearance, the parent concrete was suited to this type of repair (Coltman, 2002). The in situ concrete was reinforced with stainless steel

reinforcement (see Figure 10). The outer walls and pillars were dry-shotcreted. The inner walls were “formed and poured” using a proprietary cementitious grout with 6mm basalt fines added at a 1:1 ratio (by weight). The fines were added to aid dissipation of heat generated during hydration as well as to lower the cement content of the grout mix. Despite these measures, early age-shrinkage cracking was found to be an issue. A seal coat was placed on the face of the inside walls only. The work commenced during winter, however shotcreting of the lower section of the outer walls had to be delayed until summer months, when tides and swell conditions became more favourable.

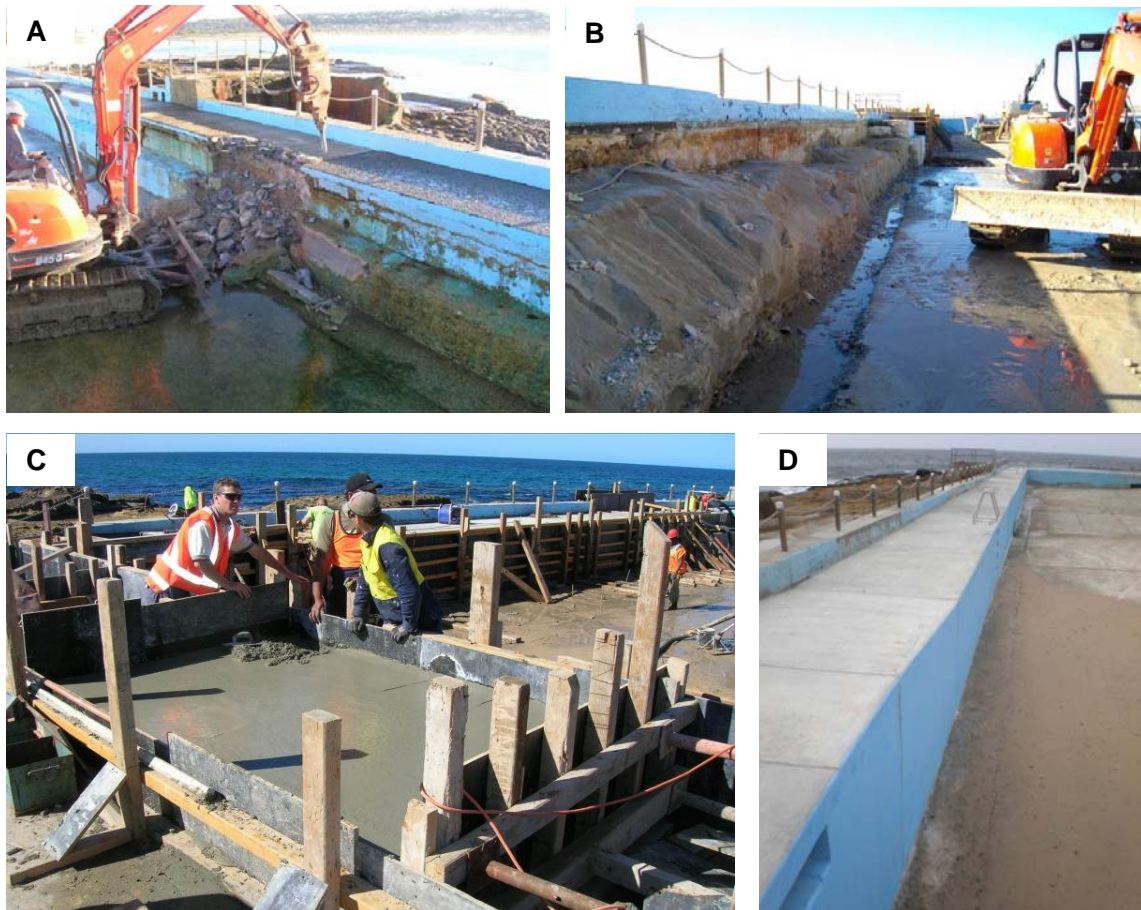
Figure 11: Refurbishment of the deteriorated north wall and apron slabs at Dee Why using mass concrete

(A) Commencement of demolition of pool wall and ledge; (B) completion of demolition; (C) placing the mass concrete units in 2.9m-wide segments; (D) the finished product. (Source: Warringah Council & WorleyParsons, 7 to 9/2009)

Rather than continuing down the path of previous repair scopes and carrying out patch and crack repairs, Warringah Council elected to undertake a more robust refurbishment of the northern wall at Dee Why. S50 mass concrete wall/apron units were cast in situ by

Silver Raven Pty Ltd. Stainless steel reinforcement was used very sparingly for anchors, trimmers and for suspending the apron slab over the top of scuppers. The aprons were widened by moving the wall some 500mm inward. This change in geometry eradicated the pre-existing ledge in the wall (see Figure 11A), formerly used by bathers as a seat. The ledge was missed by pool users, but was a prudent upgrade to comply with the safety requirements of AS2818. Patch repairs were used to repair cracks, but were of limited success (see Figure 12). These types of repairs are thought to be suited to the short term only.

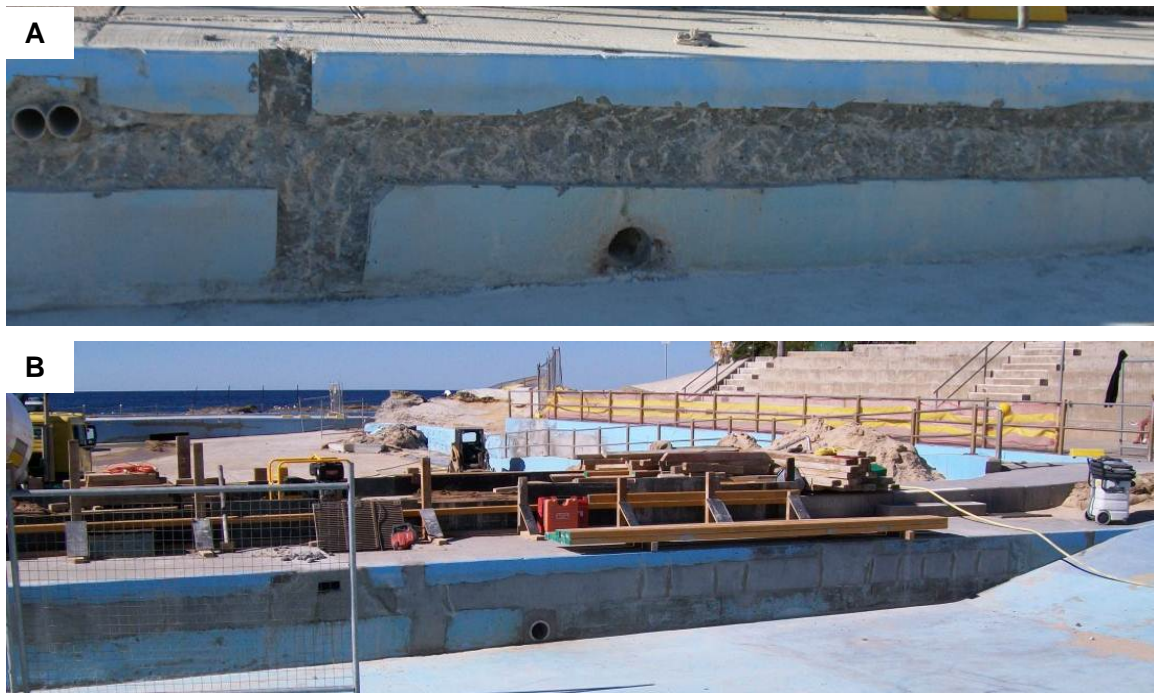
Figure 12: Patch repairs to cracked and damaged concrete – a short term solution
 (A) Preparation involved square edge cutting with obtuse angles only, and scabbling back to sound quality substrate. (B) Despite careful attention to detail during preparation and use of light stainless steel mesh reinforcement, early age-cracking of the repair mortar was encountered. (Source: Warringah Council, 7&8/2009)

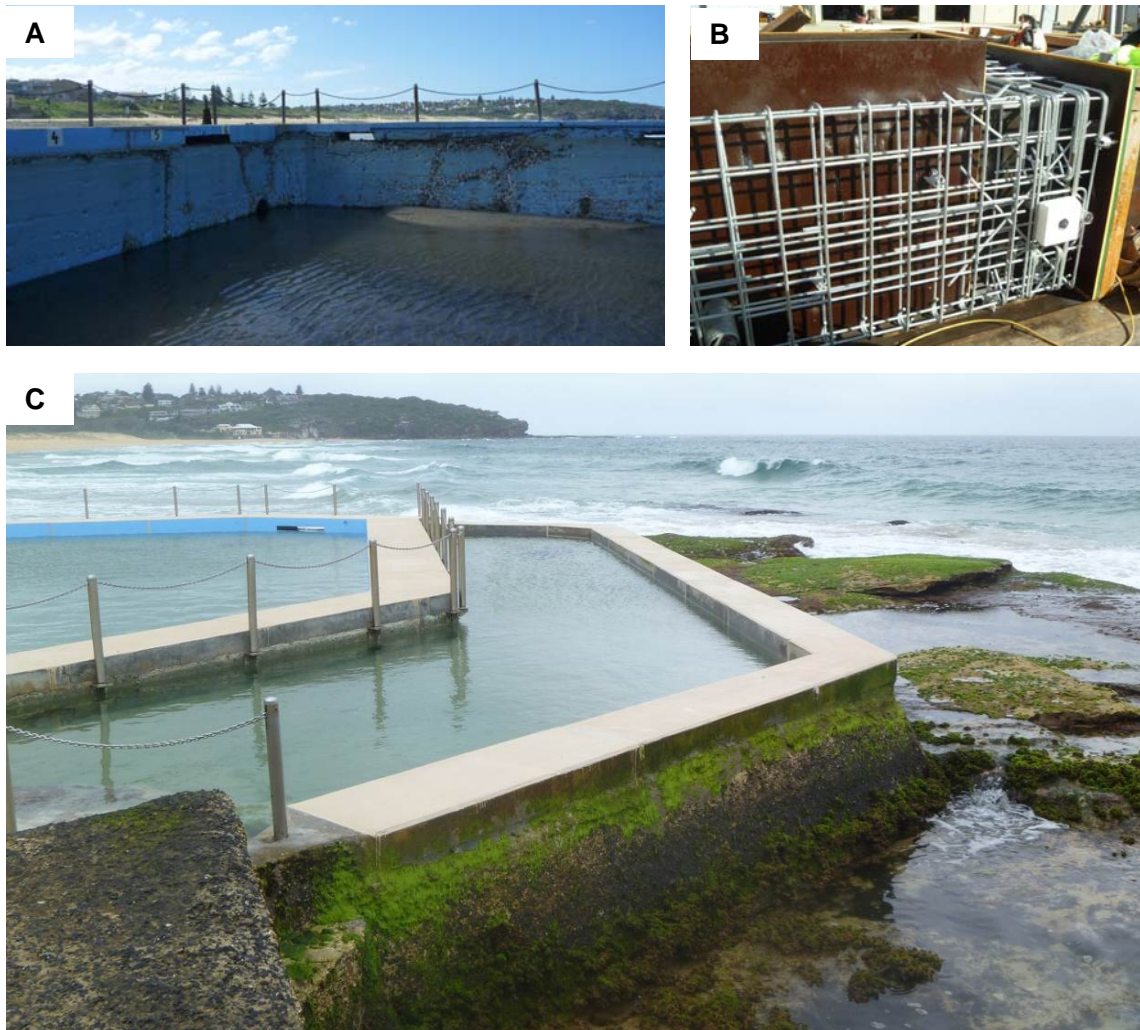
Figure 13: Refurbishment of pool walls and aprons with precast concrete

(A) Walls in poor condition. (B) L-shaped panel formed and tied in the casting yard. This panel included a formed block-out for a scupper. (C) Finished product. (Source: WorleyParsons, 4/2010, 7&12/2011)

Around half of the stainless steel posts on the side-mounted chain handrail worked loose at their fixings after less than 12 months in service (refer Figure 13C). The failure plane on the stainless steel chemset anchors was at the bond between the resin and parent concrete. Upon further investigation, the Australian Engineered Fasteners and Anchors Council advised that there is no chemical anchoring product currently available on the

South Curl Curl ocean pool was refurbished by Silver Raven Pty Ltd in 2011. The repair works involved the challenging construction and erection of L-Shaped precast concrete panels. Precast concrete was selected in order to achieve a quality and uniform surface finish and to remove the risks of formwork or reinforcement being lost/damaged and concrete finishes being compromised during in situ repairs. The top of the northern and eastern walls were cut off, and the panels were bolted and grouted in place to provide a renewed finish to internal wall and apron slab surfaces. Following completion of construction work, it was decided by Warringah Council that the risks associated with precast concrete construction in this environment outweighed the benefits.

The panels were cast with the apron (the trafficable surface) as an off-form finish. In order to achieve an appropriate slip-resistant surface, Council elected to coat the aprons with a sand-coloured poly-methyl methacrylate flooring product that had previously been successfully trialled in test panels at Dee Why ocean pool. Unfortunately, the exact product trialled was no longer available, so a substitute was used from a different manufacturer. The substitute product did not perform as well as hoped. Due to issues with adhesion, it is unlikely that this system will be used at other sites. The colouring of the topping, however, looks aesthetically pleasing and is more sympathetic to the pool's surrounds than the grey concrete (see Figure 13C).
