FACELIFT FOR AN OLD FRIEND: DISCUSSION ON OCEAN POOL REFURBISHMENT MEASURES AND CHALLENGES

J O'Reilly¹, B Mojsin¹, S Batt¹, M Zed², L Skountzos³, J Spencer⁴

¹WorleyParsons, Ports and Marine Terminals Group, North Sydney, NSW

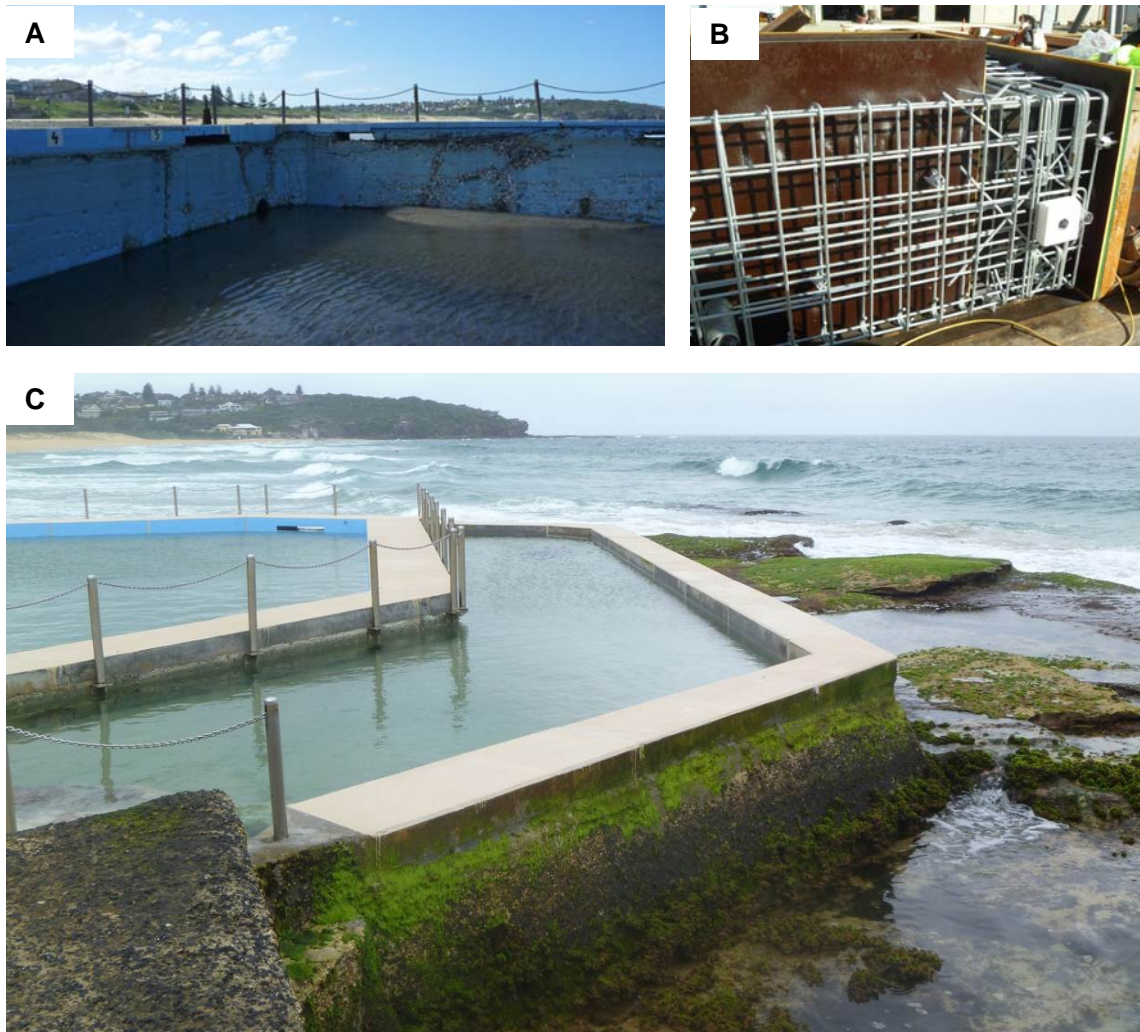
Figure 13: Refurbishment of pool walls and aprons with precast concrete

(A) Walls in poor condition. (B) L-shaped panel formed and tied in the casting yard. This panel included a formed block-out for a scupper. (C) Finished product. (Source: WorleyParsons, 4/2010, 7&12/2011)

Around half of the stainless steel posts on the side-mounted chain handrail worked loose at their fixings after less than 12 months in service (refer Figure 13C). The failure plane on the stainless steel chemset anchors was at the bond between the resin and parent concrete. Upon further investigation, the Australian Engineered Fasteners and Anchors Council advised that there is no chemical anchoring product currently available on the

The panels were cast with the apron (the trafficable surface) as an off-form finish. In order to achieve an appropriate slip-resistant surface, Council elected to coat the aprons with a sand-coloured poly-methyl methacrylate flooring product that had previously been successfully trialled in test panels at Dee Why ocean pool. Unfortunately, the exact product trialled was no longer available, so a substitute was used from a different manufacturer. The substitute product did not perform as well as hoped. Due to issues with adhesion, it is unlikely that this system will be used at other sites. The colouring of the topping, however, looks aesthetically pleasing and is more sympathetic to the pool's surrounds than the grey concrete (see Figure 13C).

market with ETA or ICC approval for use in holes wet with seawater. This issue could be addressed by use of mechanical anchors, or by ensuring that stresses in chemically anchored fixings are kept to a minimum in these applications.

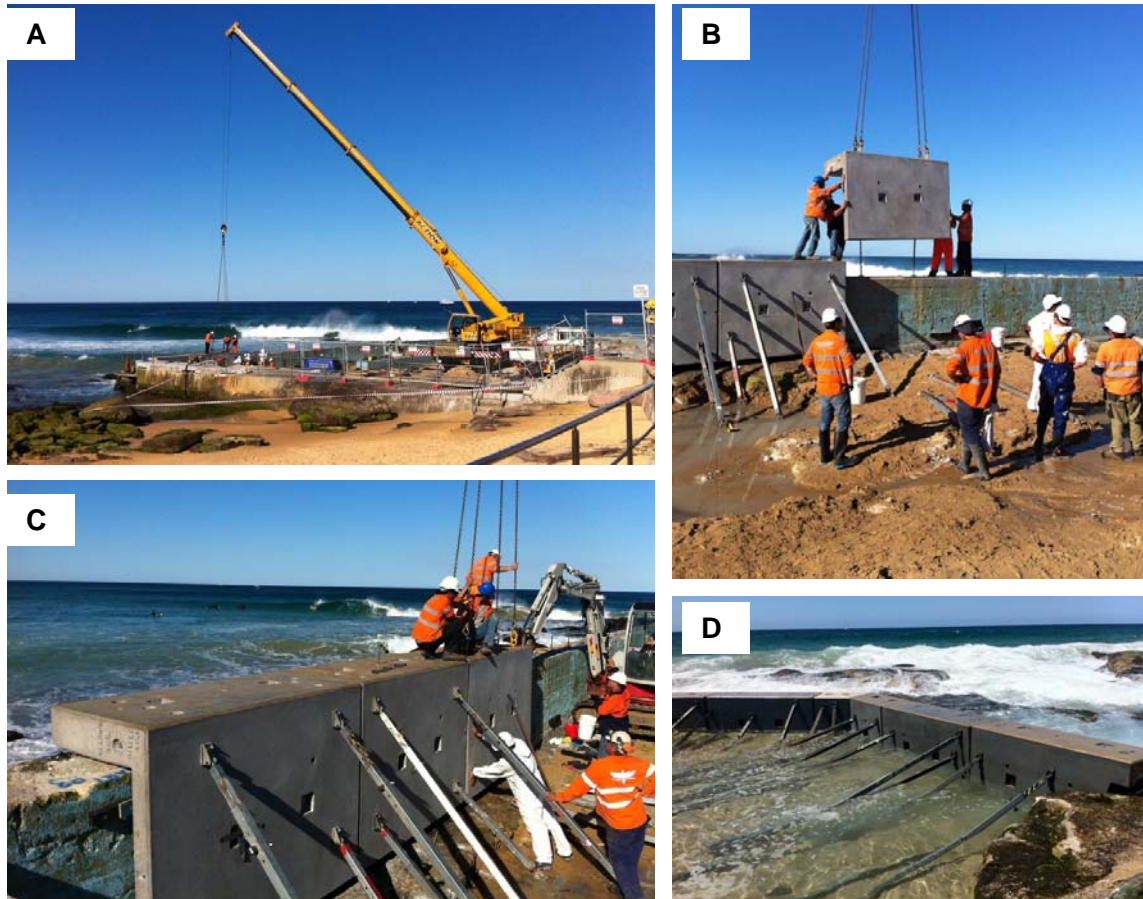
Figure 14: Erection of precast “L-shaped” units at South Curl Curl

(A), (B) and (C) Silver Raven P/L lifting panels into place – a technically challenging project in a tough environment. (D) Temporary propping of panels in preparation for inundation by the rising tide. (Source: Warringah Council, 10/2011))

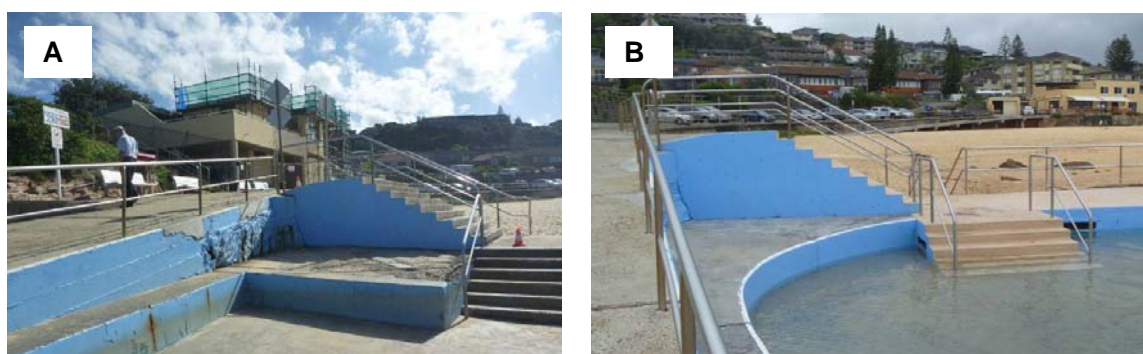
Figure 15: Before & after modifications to the SW corner at South Curl Curl

To improve surface water quality and reduce the accumulation of surface debris, the corner was radiused and a flow-through scupper placed beneath the stair. (Source: WorleyParsons, 4/2010 & 12/2011)

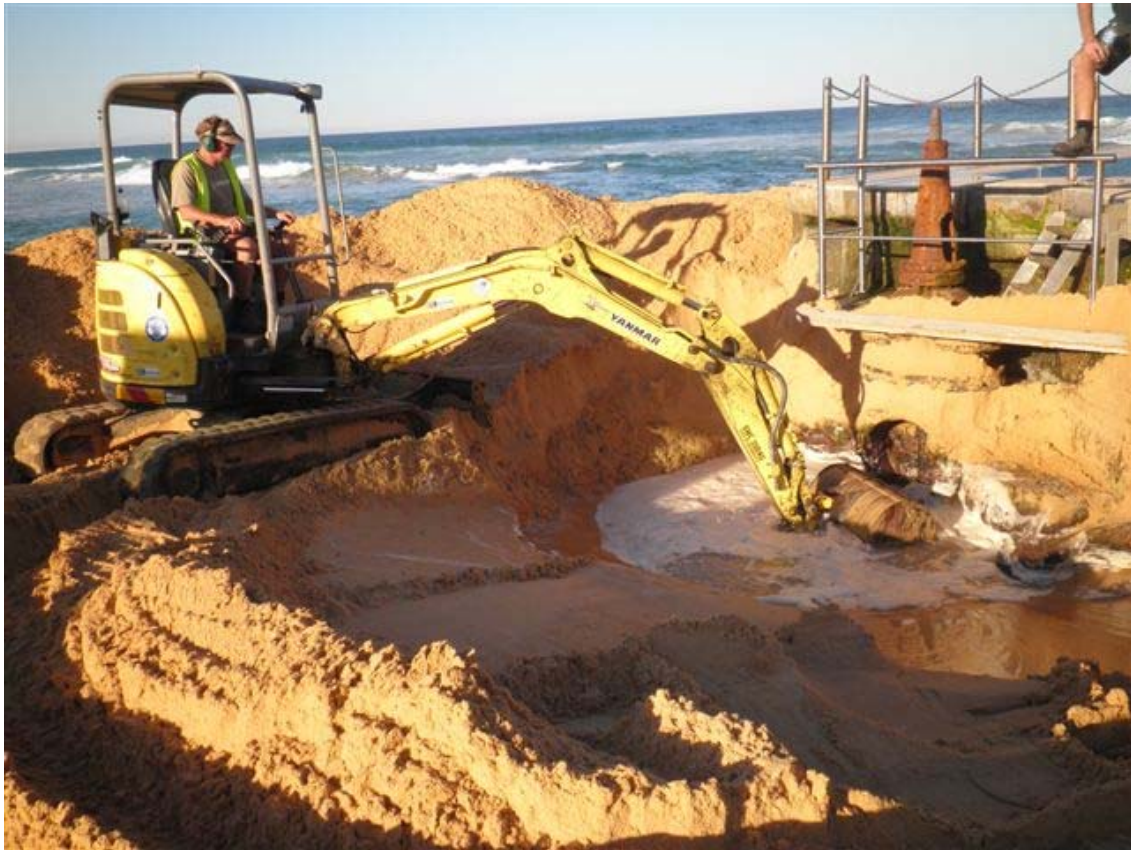
Figure 16: Racing the tide: excavation inside a temporary sand cofferdam

The first attempt at underpinning beneath the valve and pool wall was unsuccessful due to a neap low tide, highlighting that timing and patience is paramount to success in this environment. (Source: Warringah Council, 5/2012)

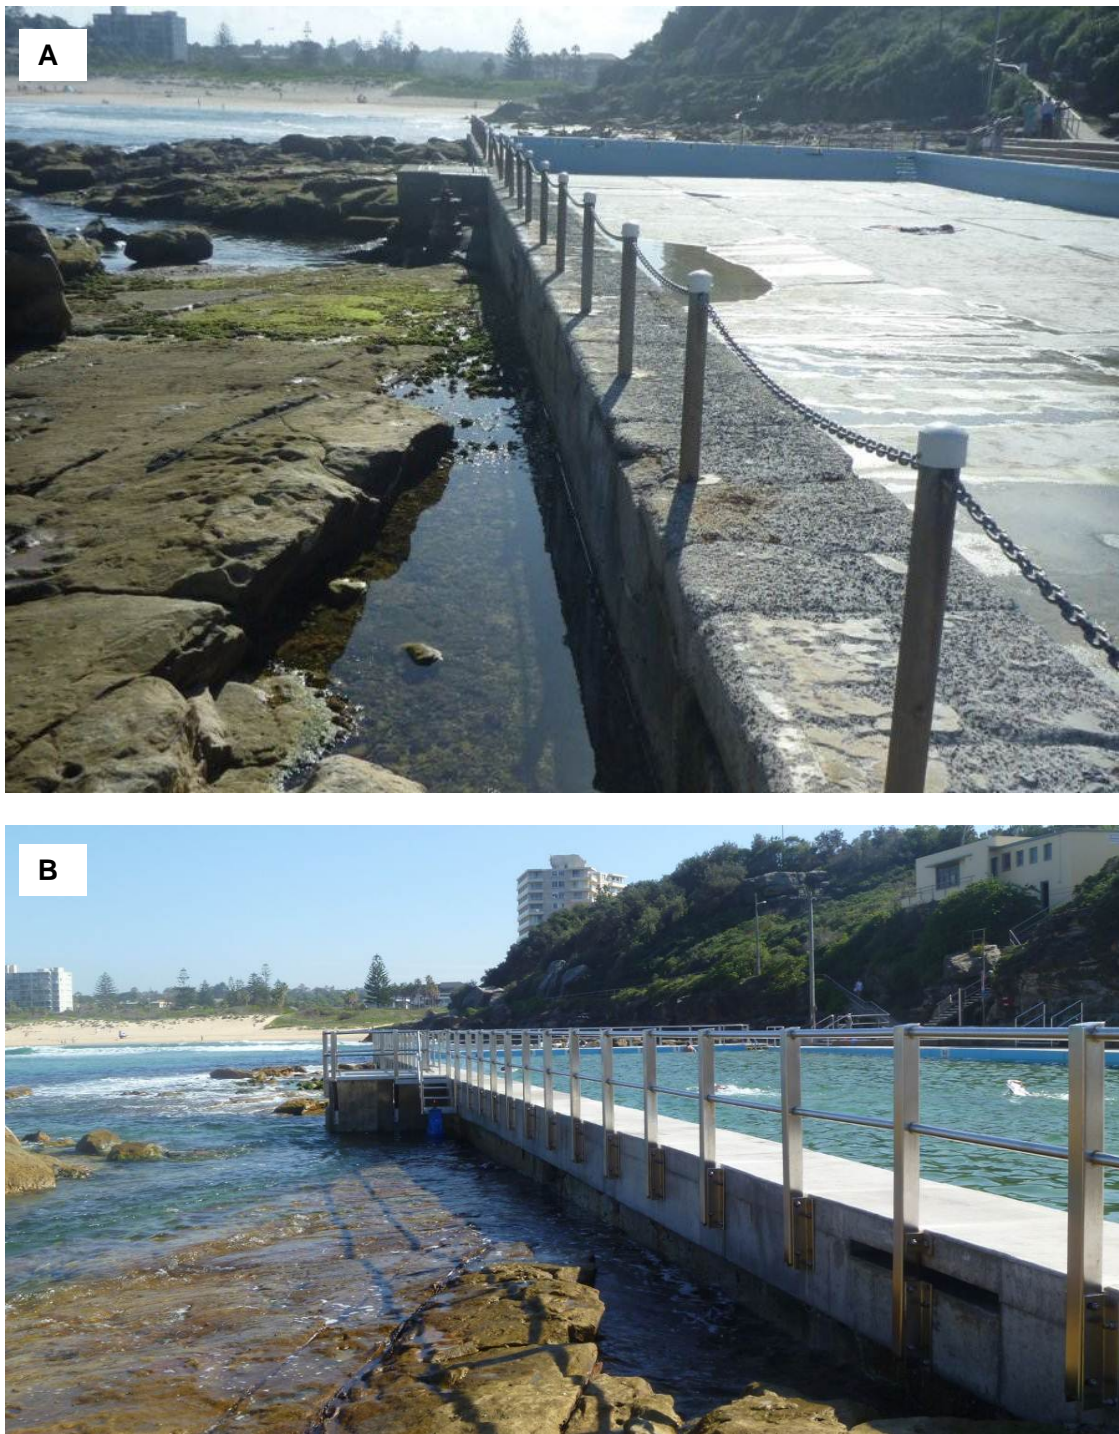
Figure 17: Freshwater: before and after

The pool’s layout has the drainage valve positioned adjacent to the pump wet well (see Figure 17). Previously, water that had been drained from the pool would be inadvertently pumped back in after the completion of internal cleaning works. This issue was ameliorated by construction of a flushing channel “upstream” of the existing channel (see Figure 18). During the refurbishment work, Council took the opportunity to replace the wet well with a deeper version, to allow operation of the submersible pump during all tidal conditions. In addition, a second pump was installed to facilitate constant and reliable circulation of water. The successful upgrades to improve water quality and maintainability

(A) Narrow southern apron in poor condition. (B) The pool was deepened by raising the coping and scupper invert levels. Warringah Council took the opportunity to slightly widen the narrow southern apron. Useable apron width was maximised by installation of a side-mounted guardrail. (Source: WorleyParsons, 4/2010 & 5/2013)

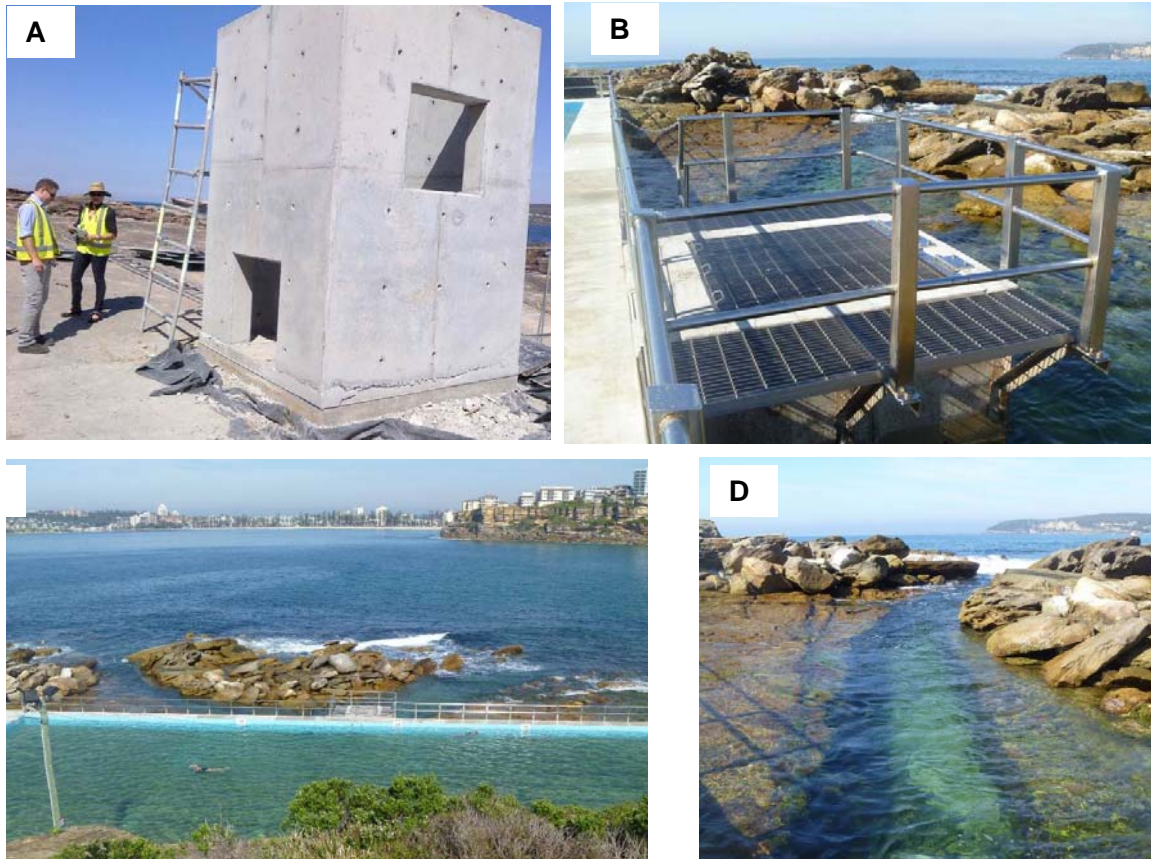
Figure 18: Modifications to the pool pump system at Freshwater

(A) Replacement pool pump wet well, precast on site. (B) Wet well installed on south side of pool with electropolished stainless steel work platforms and access hatches. (C) New flushing channel (channel through rock on the left) allows circulation of "fresh" water to the pool pump. (D) Close-up of the new flushing channel excavated into rock. (Source: WorleyParsons 9/2012 & 5/2013)

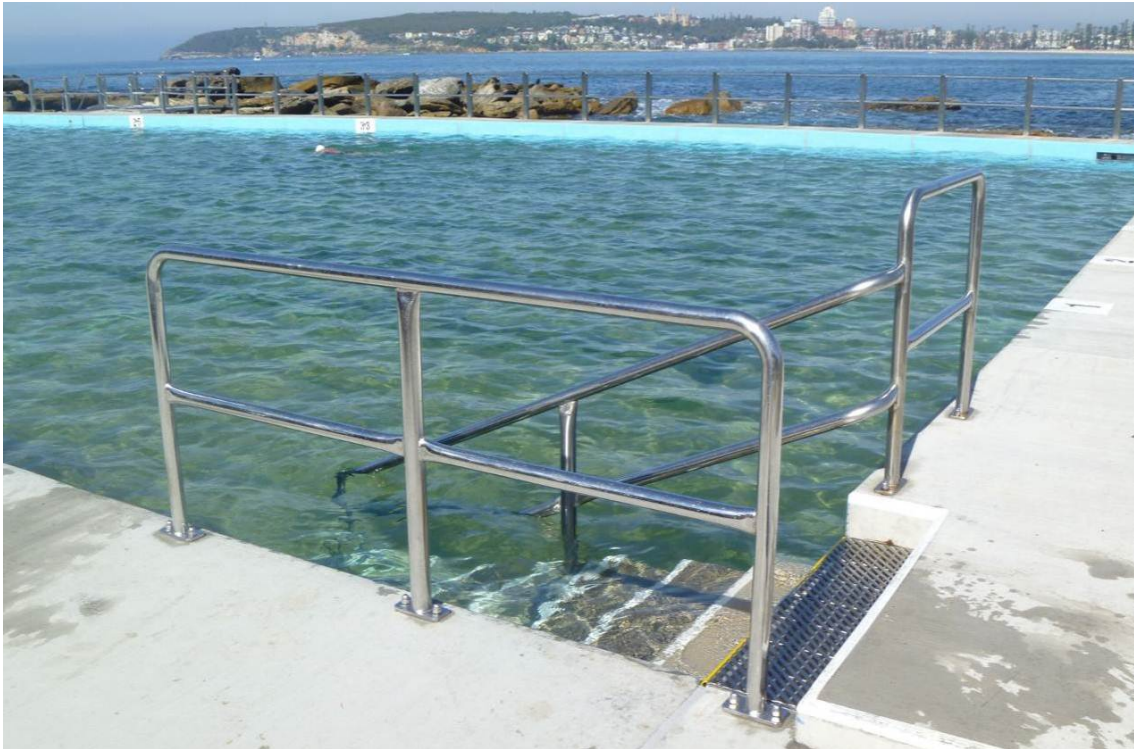
Figure 19: Slender scupper lid being trialled at Freshwater

Fabricated from electro polished stainless steel plate and acting as a step. A potential solution to the issues shown in Figure 8. (Source: WorleyParsons 1/5/2013)

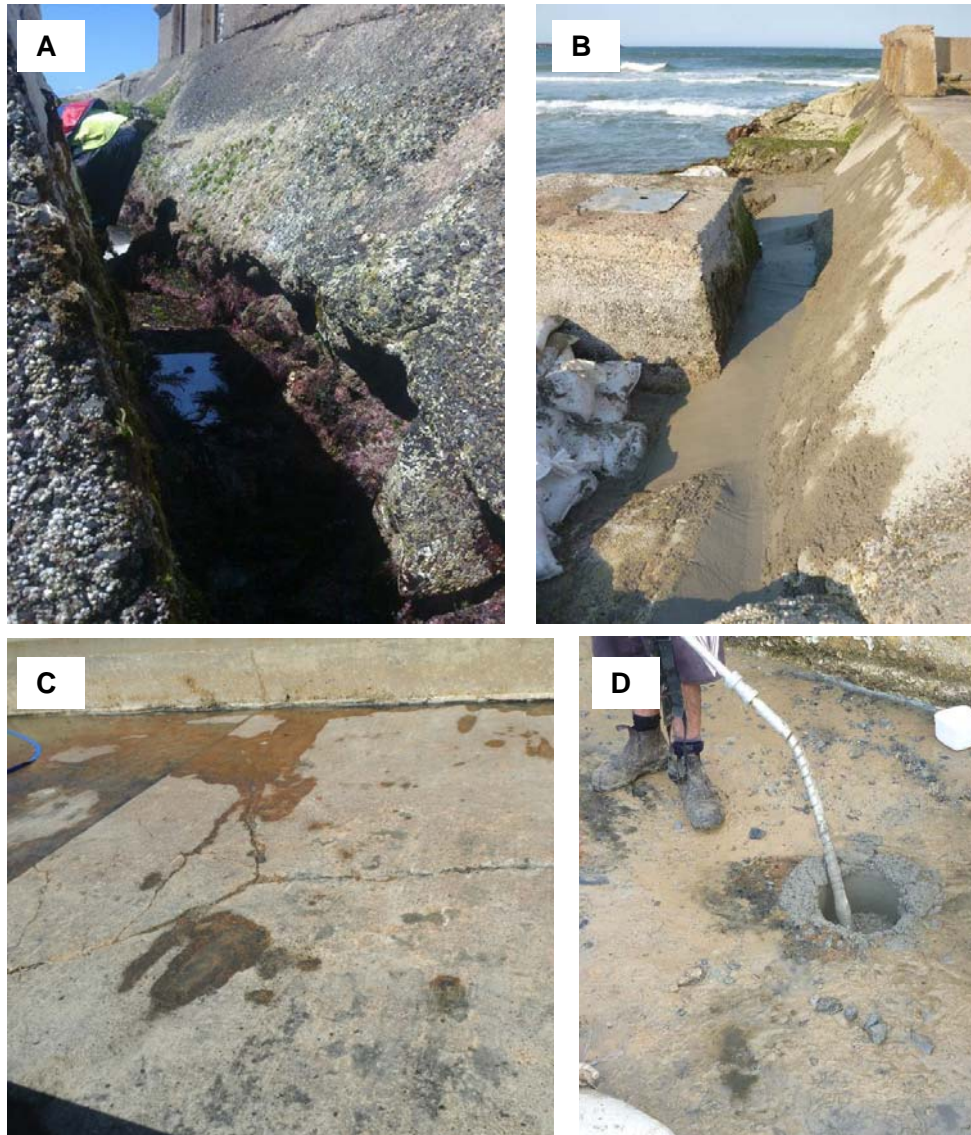
Figure 20: Mass concrete underpinning at Yamba

(A) The toe of the northern wall showing signs of scour and undermining. (B) Mass concrete with stainless steel dowels used to underpin the toe of the northern wall. (C) Central panel shown cracked and leaking. (D) Underpinning the floor slab at the pool's deep end. Worker shown vibrating concrete into a corehole following local dredging of material beneath the slab. (Source: Chambers Constructions & WorleyParsons, 9-10/2012)

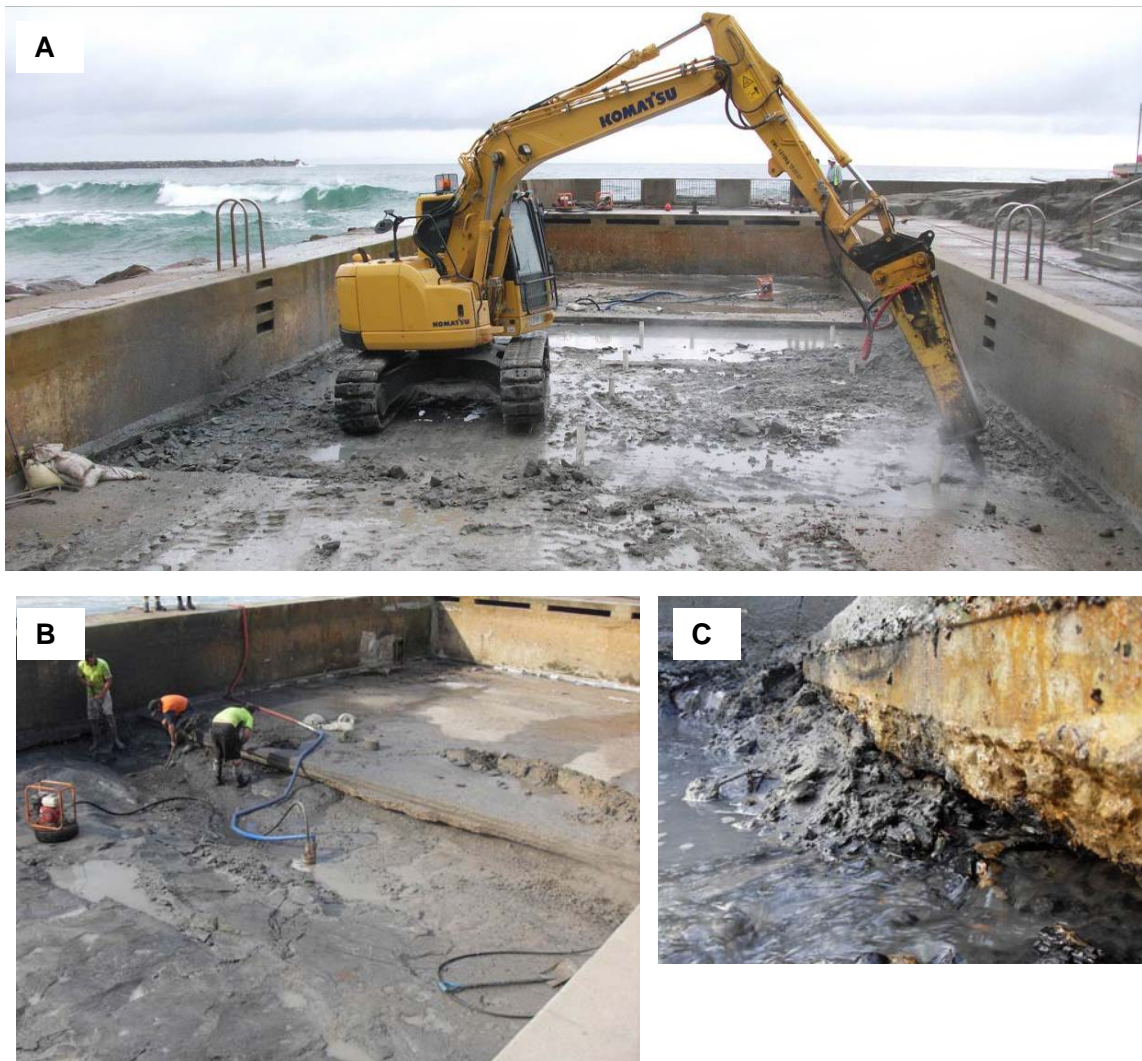
Figure 21: Demolition of the middle floor slab panel at Yamba

(A) Rubber-tracked rock-breaker lowering bedrock levels to allow placement of a floor slab of uniform thickness. (B) Foundation preparation, involving removal of sand and silt and placement of a mass concrete blinding layer. (C) Water flowing freely beneath the floor slab at low tide. (Source: WorleyParsons, 11/2012)

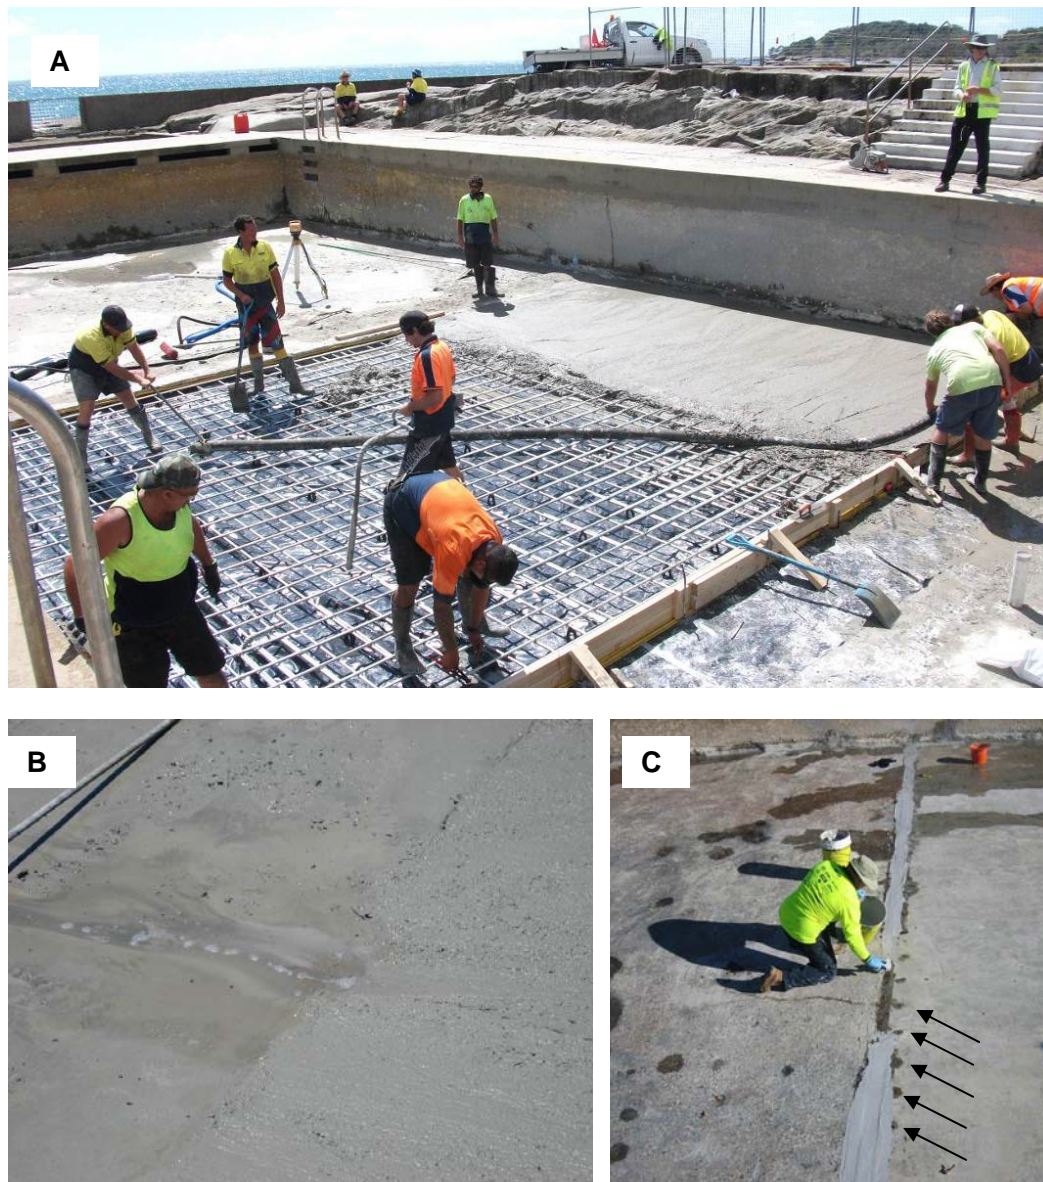
Figure 22: Placement of a new pool floor slab panel

Due to program constraints, the floor slab was placed on a rising tide. The high permeability of the substrate beneath the slab, and the failure of previous measures to prevent the flow of water from beneath, resulted in water leaking through the slab joints before it had cured. Local water-proofing specialists, Caps Beta, were called in to rectify the leaks. A temporary foaming hydrophobic polyurethane water-stop was first used,

(A) Concrete being pumped and screeded into place. (B) Despite best efforts, delays in placing the concrete meant that the tide rose before the new concrete could set, and the new floor slab began leaking immediately. (C) Specialist repair of leaks by filling the excavated slab joint with epoxy mortar. Note the water pressure relieving holes drilled along the seaward side of the joint, marked with arrows. (Source: WorleyParsons, 11/2012; Jim Spencer, 12/2012)

followed by filling of the excavated joint with an epoxy mortar primer and grout (see Figure 22).

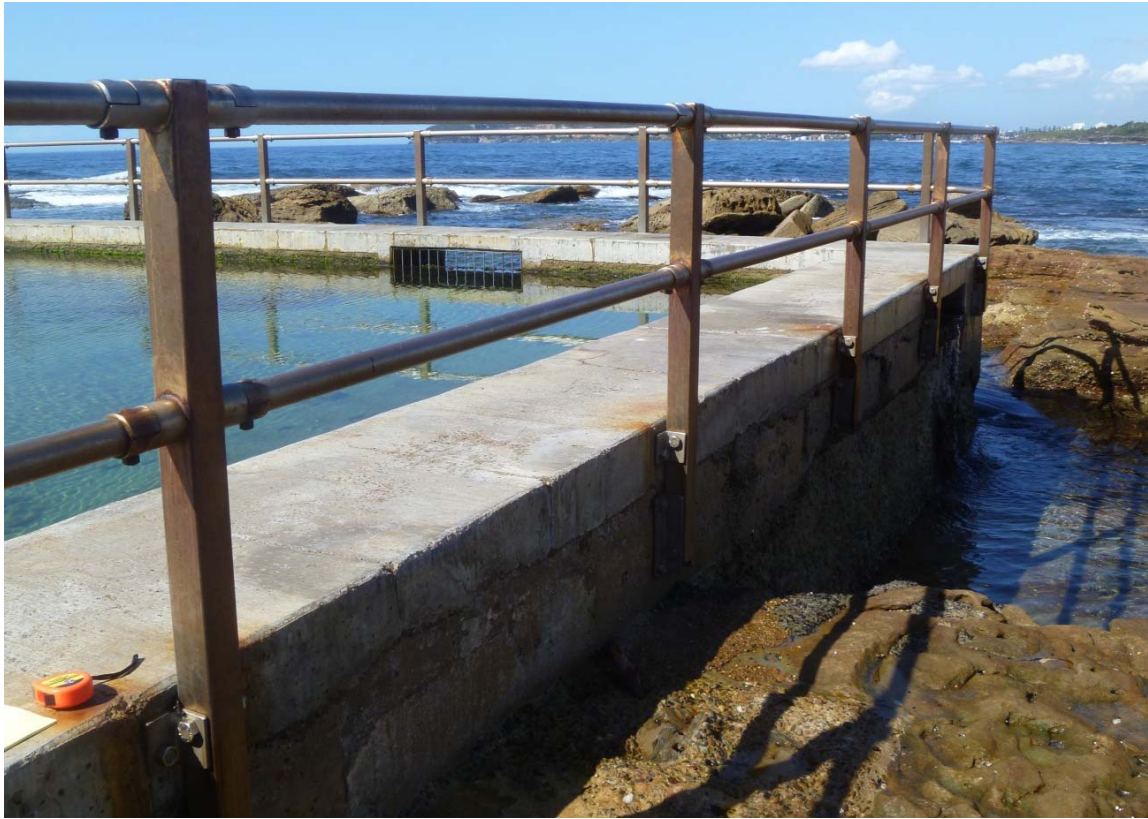
Figure 23: Heavy-duty, modularised double guardrail at North Curl Curl

North Curl Curl is exposed to heavy seas and is typically inundated by waves each high tide cycle. This pool has a known history of destruction (see Figures 1 & 8). Previous generations of chain handrails at this site were typically not able to stand the test of time (DPWS 1995; Mayne-Wilson, 1998 & 1999). A robust double guardrail was installed in

1998 and remains today at this site, with only minor signs of deformation. It was built using modular components, such that individual items could be removed and replaced on site using hand tools. Rails are $\phi 60\text{mm}$ CHS and posts are 80mm SHS, austenitic 316 stainless steel. The double guardrail format and large diameter rails do not comply with the requirements of the Building Code of Australia (BCA).

This rail is still performing adequately after 15 years in service at an unforgiving site. (Source: WorleyParsons, 3/2012)

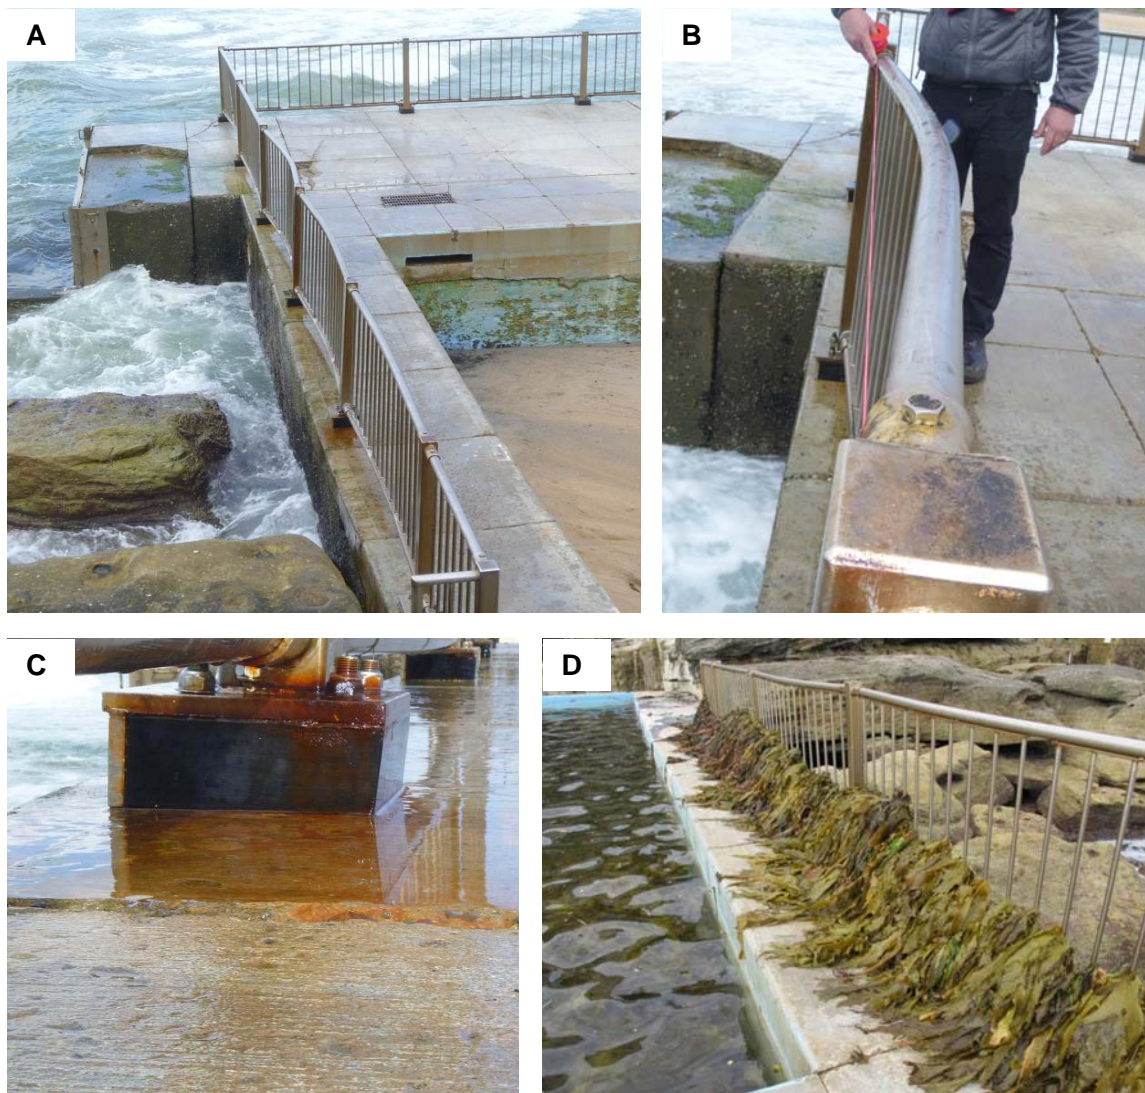
Figure 24: BCA compliant balustrade at Queenscliff ocean pool

The balustrade around Queenscliff ocean pool is similar to the handrail at North Curl Curl in that it was built from 316 stainless steel using modular components. It was fabricated from $\phi 48\text{mm}$ rails and 80mm SHS posts of the thickest wall readily available at the time. (ASSDA, 2005). It is BCA compliant and has removable infill panels made up with 20mm rod balusters. The posts are mounted above 75mm-thick neoprene “shock pads” (see Figure 24C) that are designed to absorb energy in the direction of oncoming waves only. The original design brief for this balustrade was to absorb the impact energy of boulders carried by waves (as these were reported to be found inside the pool from time to time). It was later found, however, that the ultimate load case for the balustrade is the increased drag and inertial forces from wave loading once the rails are covered with weed (see Figure 24D).

(A) After 14 years in service, the balustrade along the eastern wall is ready for replacement. (B) Unacceptably large deformations were measured at the top rail and posts. It now encroaches on the already narrow apron. (C) Neoprene shock-absorbing pads beneath the balustrade posts, designed to absorb energy from rock impacts. (D) Significant quantity of wrack caught on the balusters. (Source: WorleyParsons, 3/2012 & 7/2013)
